HO-1045

Walker-Anderson House

840 Ridge Road

Maryland Inventory of Historic Properties Form

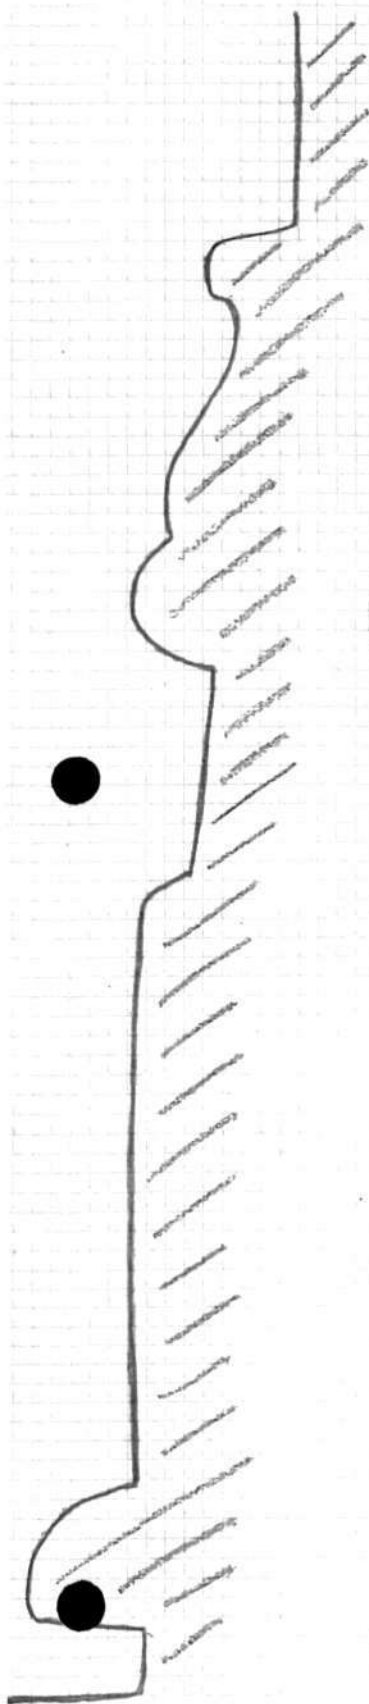
Baseboard

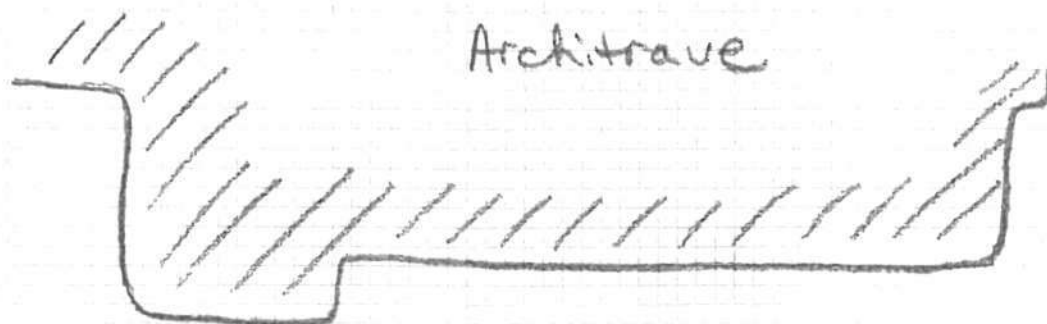
Architrave

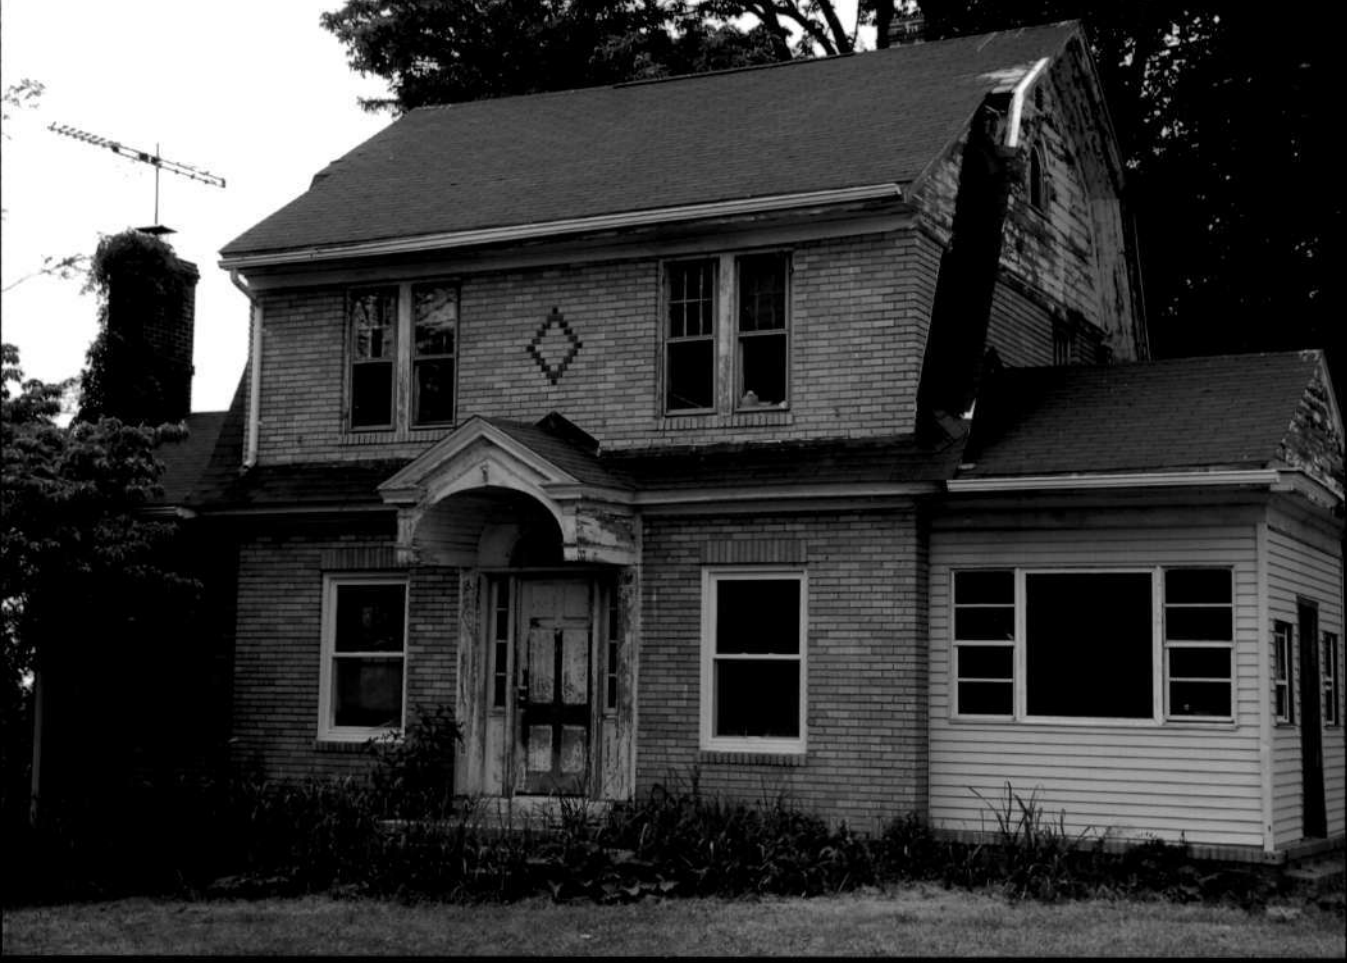
Walker-Anderson House
840 Ridge Road
Howard County, Maryland
Ken Short
2011-06-10
MD SHPO
House, southeast elevation
1 of 6

The southeast elevation of the main block has a center entrance on the first story with a six-panel door, fanlight, and sidelights with four lights over one panel. There is a gable-roofed porch that is missing its supporting columns and has pilasters against the wall. The semi-circular arched soffit has bead boards. The cornice on the house continues on the porch with returns on the front of the porch and a raking cornice. The arch breaks into the tympanum. There is a new one-over-one sash to each side of the door, with brick sills and straight brick jack arches. On the second story of the main block, the center bay has a hollow diamond pattern laid in brown brick, with paired six-over-one sash to each side. The fake gambrel applied to the house creates a pent-roof appearance between the first and second stories. There is a wood box cornice on the second story. The southwest wing has paired six-over-one sash, a lower gable roof with a northeast-southwest ridge, and an exterior red brick chimney on the southwest gable

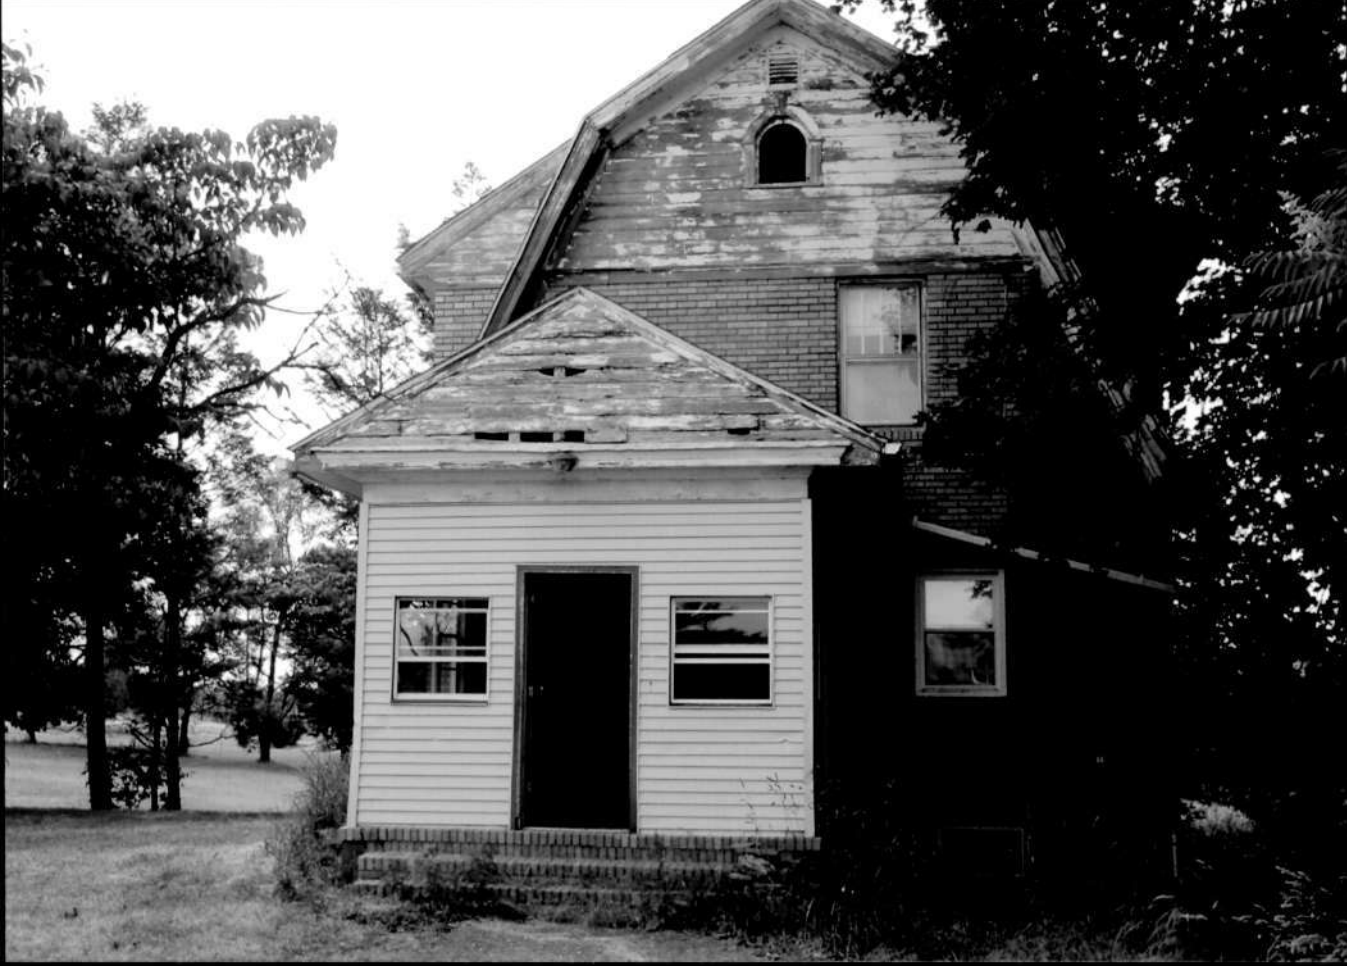
2 of 6

House, northeast elevation

The northeast elevation of the northeast wing is enclosed just as on the southeast elevation. The gable end has very weathered weatherboards. The cornice wraps on all three sides, but the roof extends beyond the cornice on the northwest and southeast, with a new cornice covering the old one. The roof appears to have been added later, perhaps to cover an original flat roof. The north bay of the main block has a new one-over-one sash on the first story. The northeast wall of the main block, where covered by the enclosed porch, has a door in the east bay with one light that has been broken out and boarded over. At the north edge of the porch are two steps down to a doorway that is missing its door; this leads into a landing for steps down to the basement and up to the kitchen. The floor of the porch is quarry tile. The upper story has a six-over-one sash set north of center. The brick ends at the top of this window, with German siding above that contain a semi-circular arched window opening with pilasters and a keystone, and with the sash broken out.

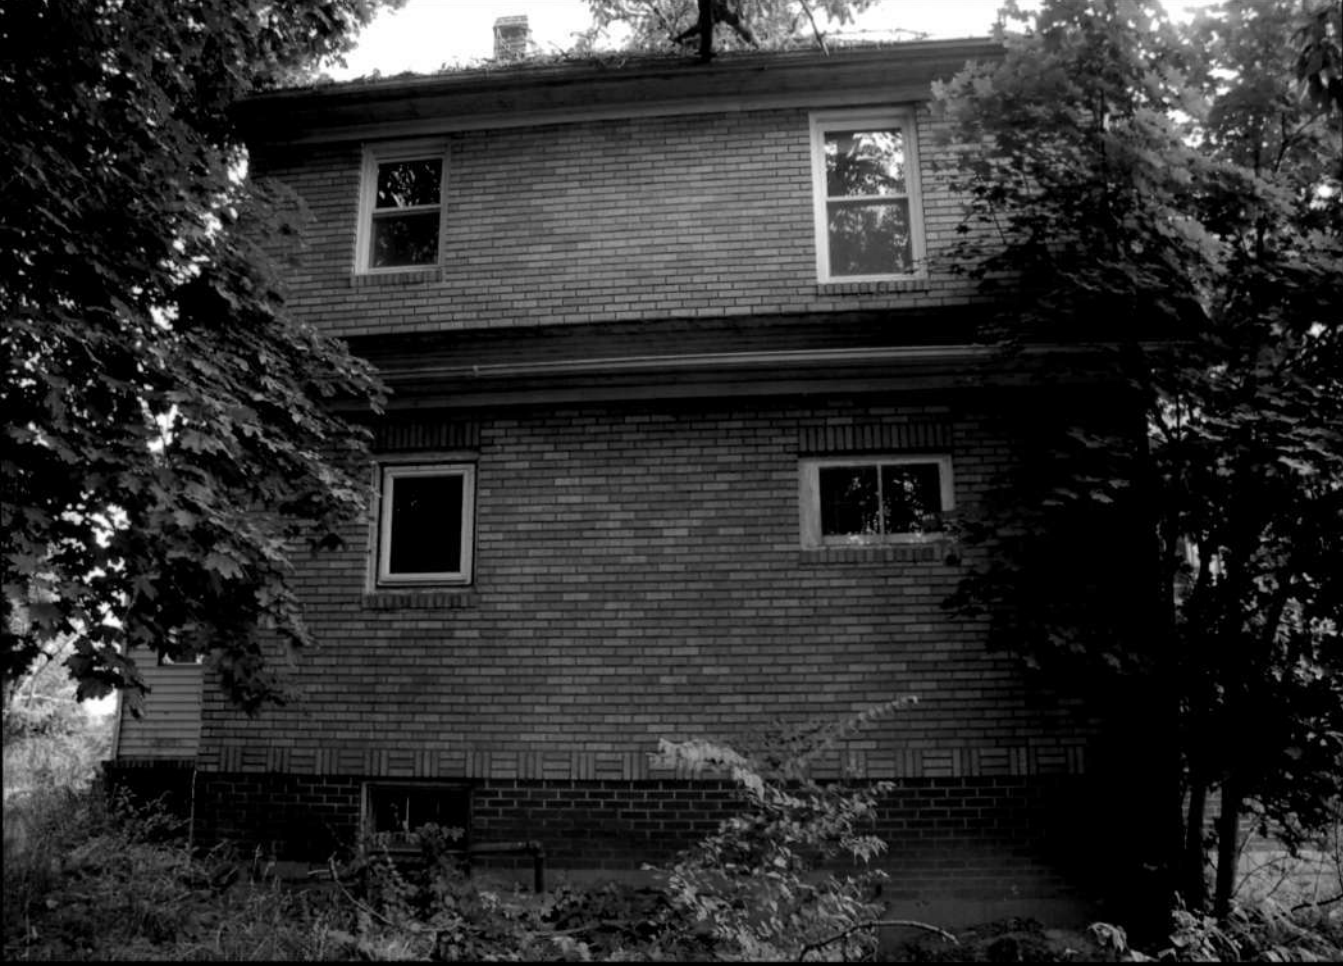
3 of 6

House, northwest elevation

The northwest elevation foundation has CMUs below the strip of red brick. The first story has a new one-light sash in the north bay and a ten-light casement sash in the west bay. There is a pent-roof between the first and second stories, as on the front. The second story has two new one-over-one sash. The northwest elevation of the southwest wing has paired six-over-one sash.

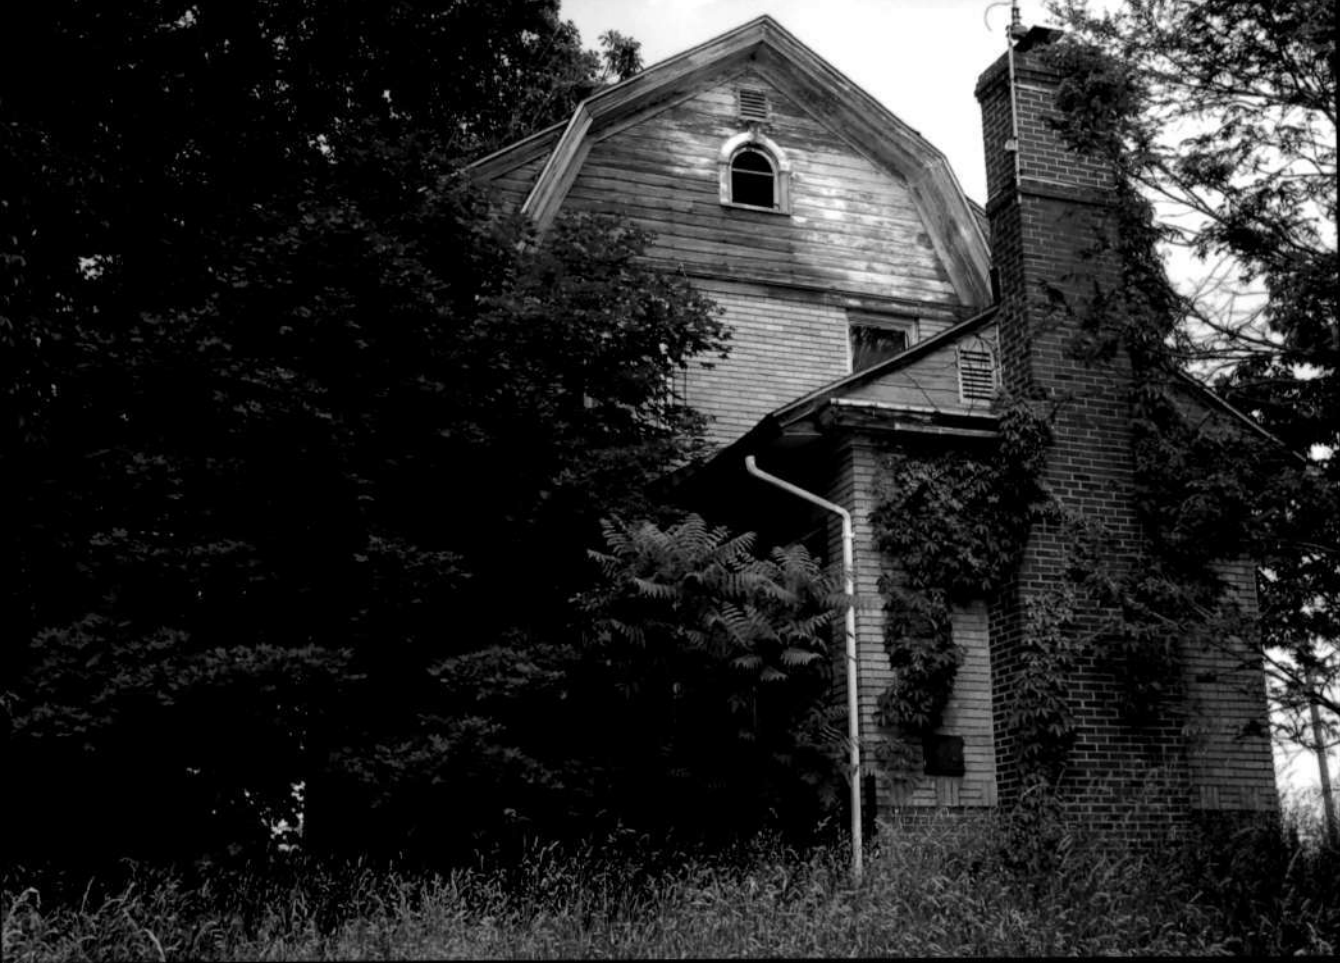
4 of 6

House, southwest elevation

The southwest elevation of the southwest wing has an exterior chimney in a wire-cut brick, and it covers a brick jack arch, with seams on both sides of the chimney for what must have been a large opening. The roof and cornice match that of the northeast wing and must also be added. The southwest elevation of the main block has a new one-over-one sash in the west bay of both the first and second stories. There is a one-light sash just above the ridge of the southwest wing. The gambrel end is identical to the northeast end.

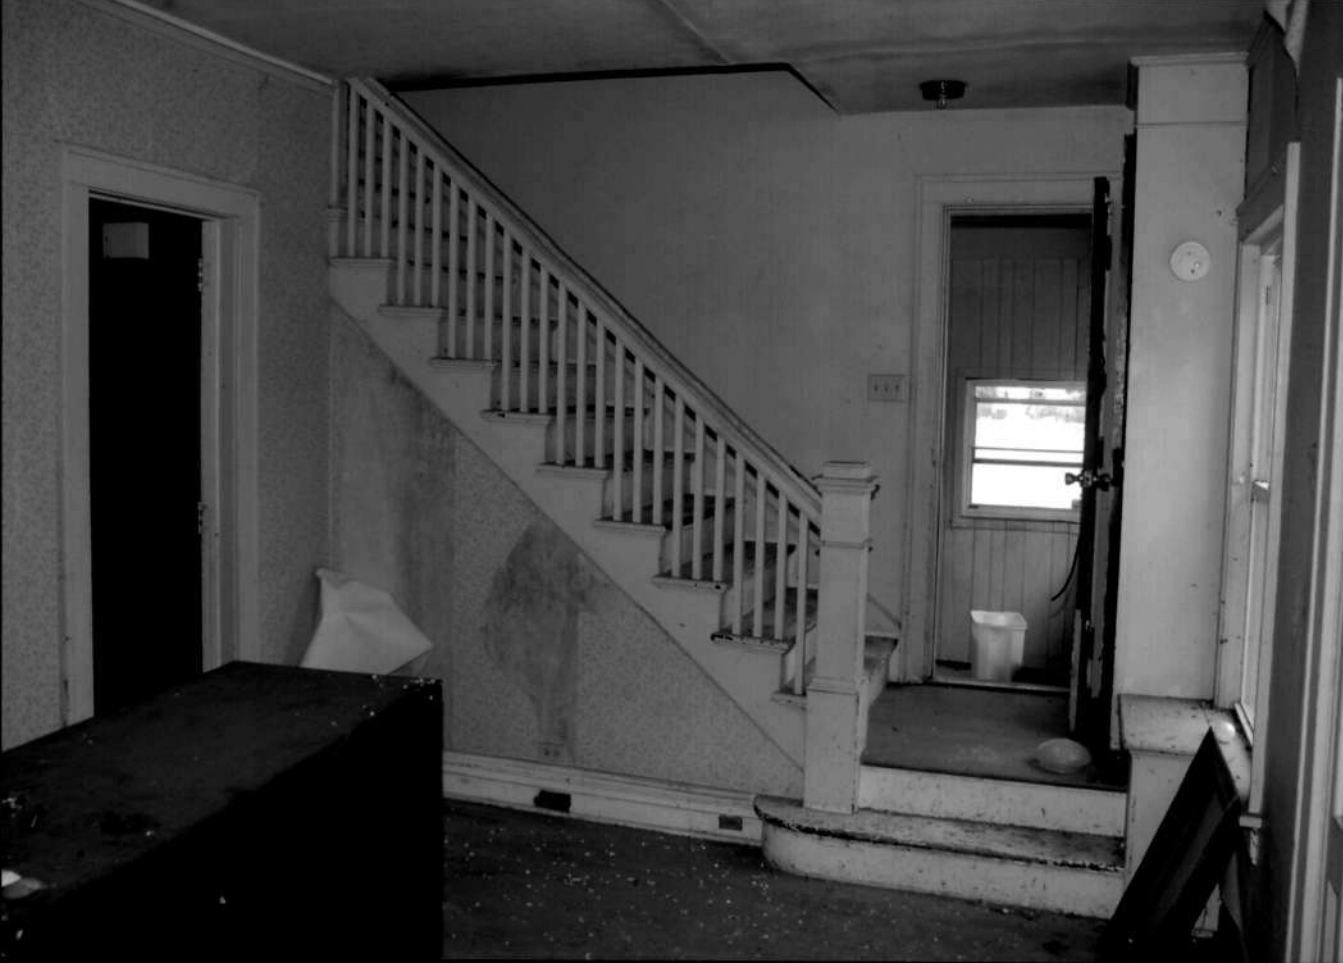
5 of 6

House, interior, southeast room,

vw. northeast

The first story has one large room across the front of the main block, with the stairs at the northeast end of this room, two rooms to the rear of this room, and one in the southwest wing. There is 1 1/2-inch tongue-and-grooved oak flooring running northwest-southeast throughout the house. The walls are plaster, and some ceilings have drywall that appears to be a later alteration. The southeast room has baseboard with a wide, flat ogee and bead above a broken field. The architrave is plain and flat, with a plain narrow backband. There is a wide-arched opening on the northwest, set to the west, that leads to the west room. The doors are hung on butt hinges with ball finials. The stair has a dogleg and ascends to the northeast landing, then turns to the northwest. It has a plain open stringer, a square newel typical of the c. 1920s, square balusters, and a moulded handrail. There is a door on the stair landing that leads to the northeast porch. A narrow wood cornice has been added to the room.

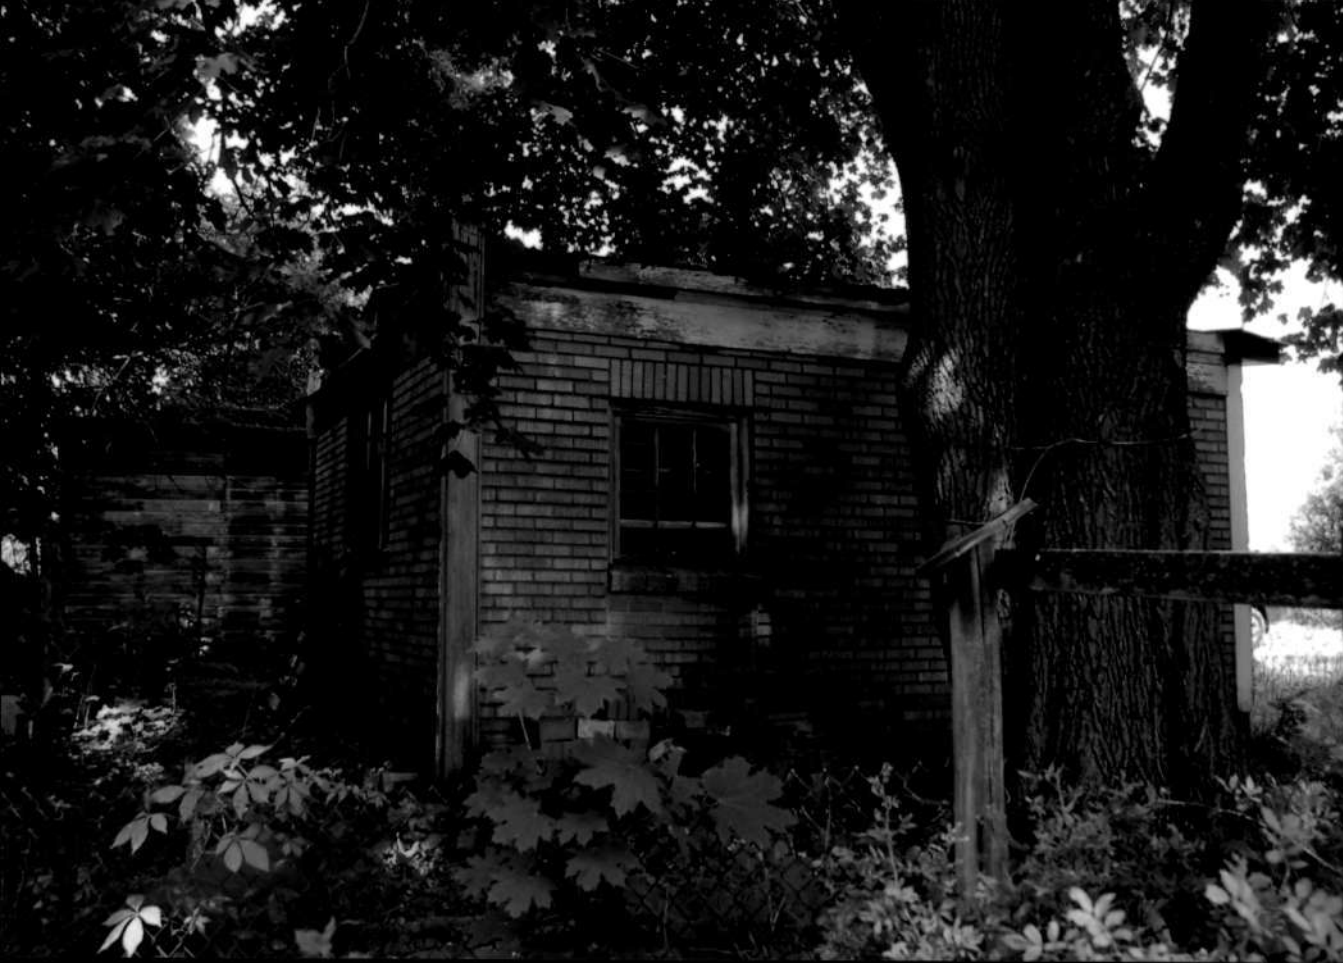
6 of 6

Garage, northwest & southwest
elevations

There is a one-story garage located about 20 feet north of the house. It has a red brick foundation, yellow brick walls, and a low gable with a northwest-southeast ridge and inverted-v-seam metal. There is T1-11 siding added to the southeast. The large door on the southeast is gone. The northwest elevation has triple six-light sash. There was a door on the southwest, set to the west, but this opening has been in-filled with yellow brick and a six-light sash. The interior walls are CMUs.
